EN 1634-1:2014/A1:2018

Fire Resistance Test for Doorset incorporating Electronic lock H2

Zhongshan Jiahui Technology
Company Limited

Product: Fire-resistance doorset with electronic lock
 Manufactured by: Zhongshan Jiahui Technology Company Limited
 Model: H2

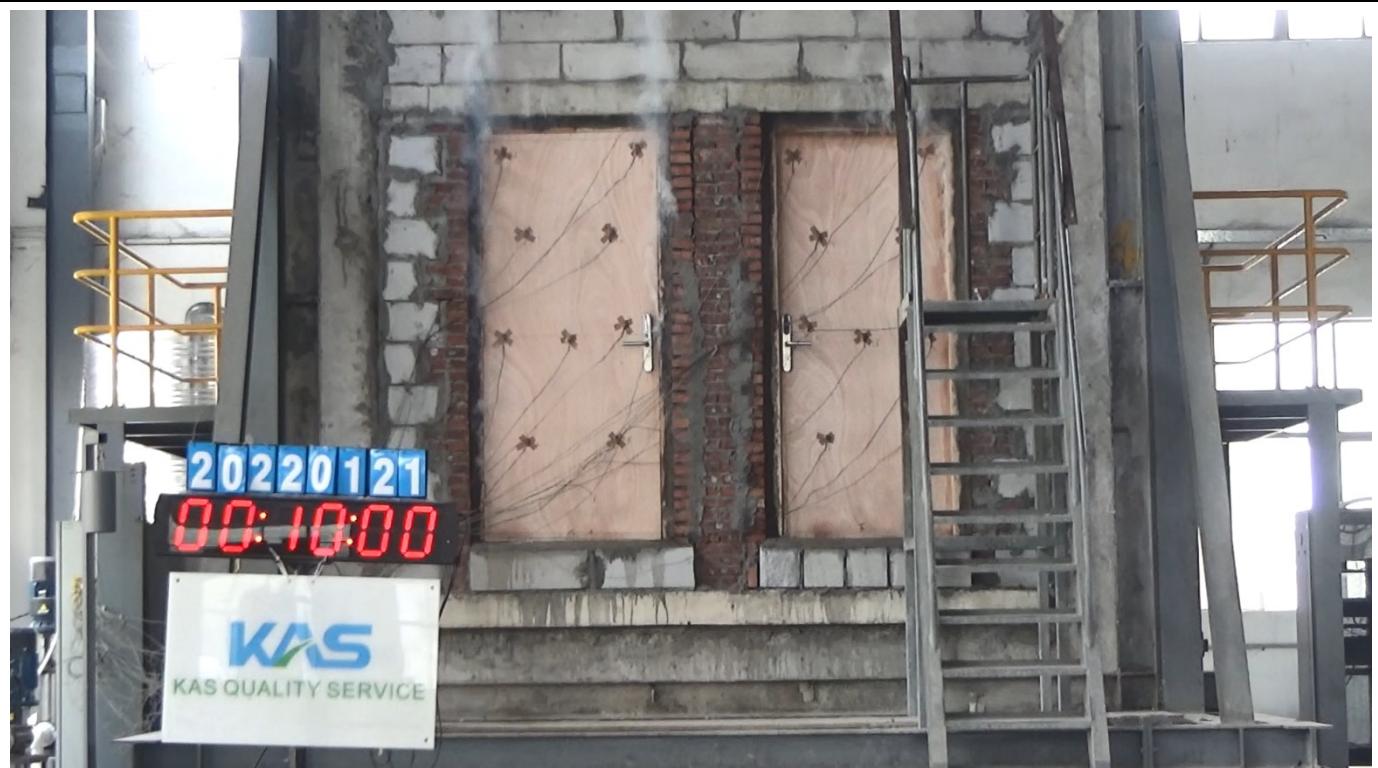
After 10 min (Unexposed Side)

Time mm: ss	Observations
0:00	The test commences.
2:02	Dense smoke released from each edge of doorsets.
9:04	Each edge of doorset B began to get wet; The right edge of doorset B began to turn black.
20:34	The smoke release decreased. The left edge of doorset A began to turn black.
30:41	The top edge of doorset B began to turn black.
42:39	Each edge of doorset B began to turn black.
62:17	No integrity and insulation failure had occurred; The test was terminated after a period of 62 minutes at request of the sponsor.

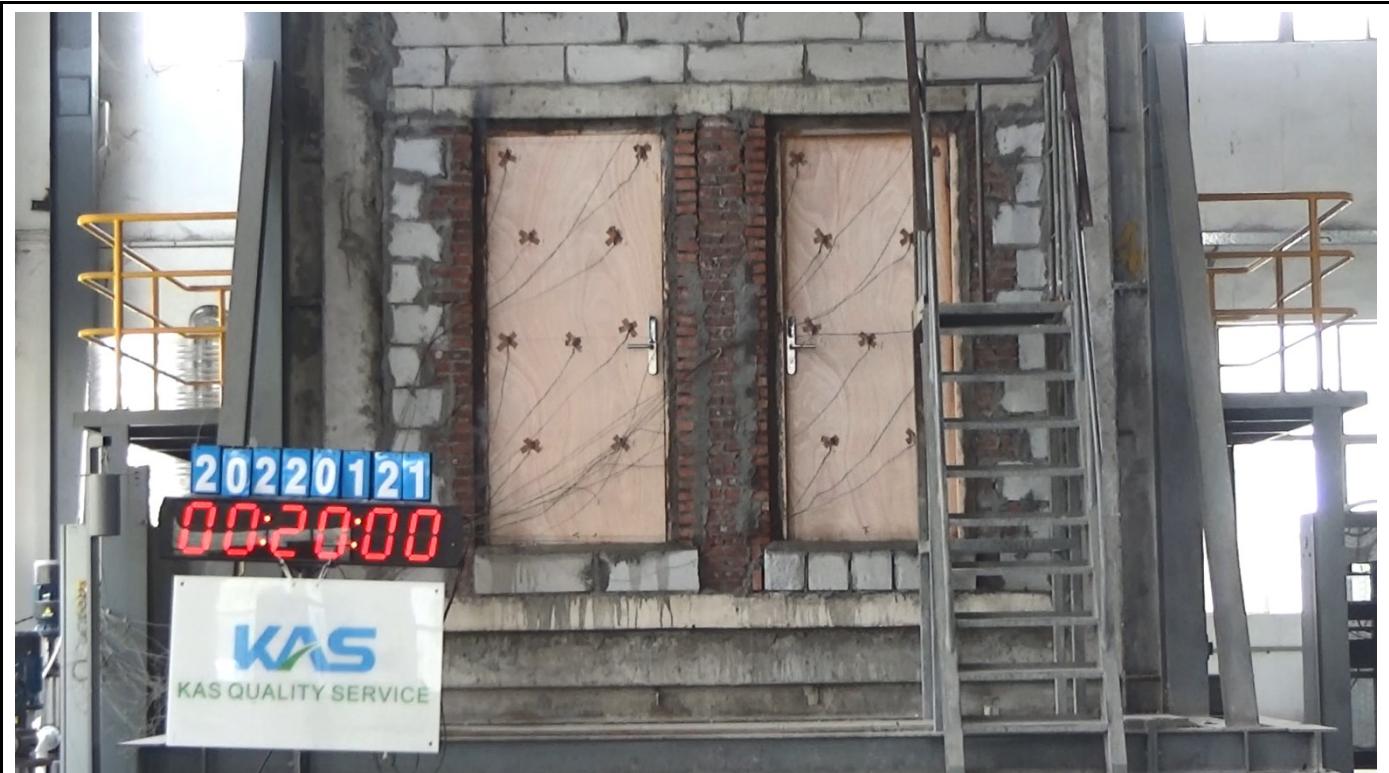
After 20 min (Unexposed Side)

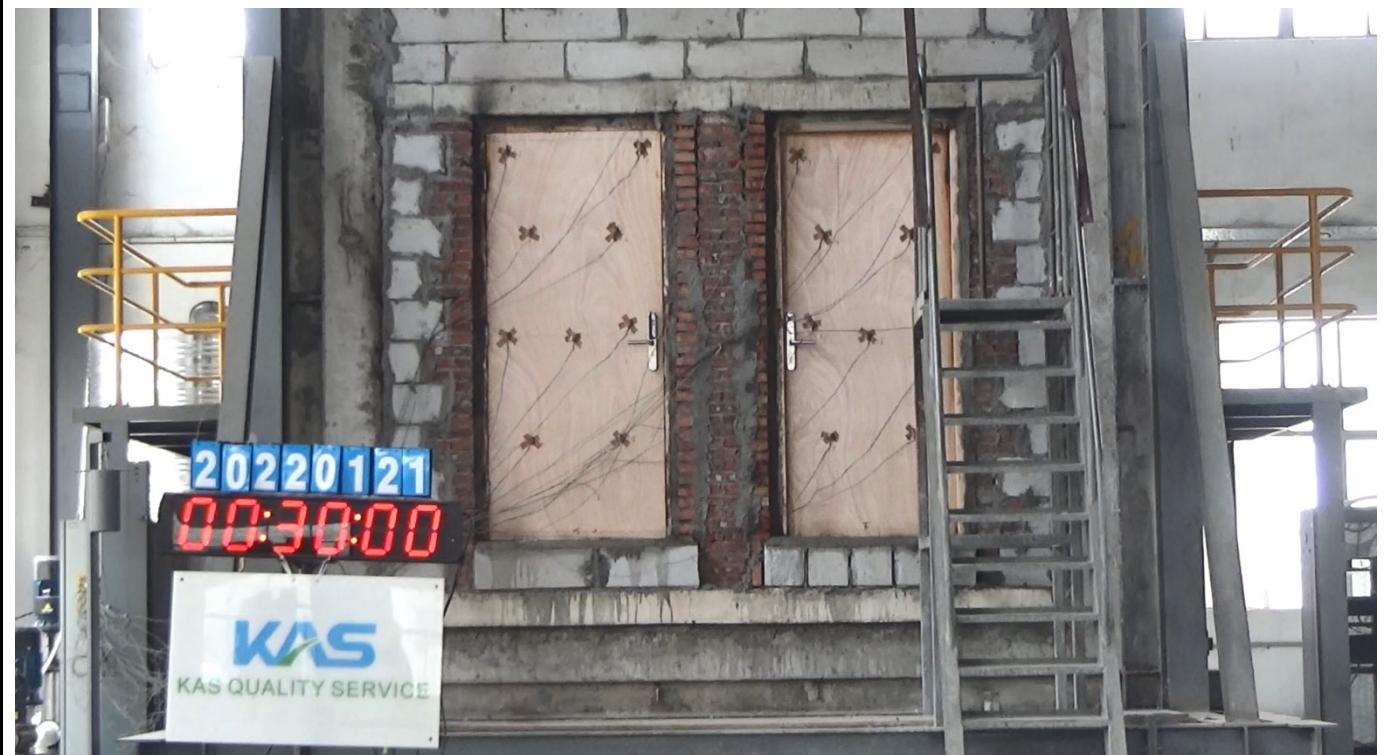
After 30 min (Unexposed Side)

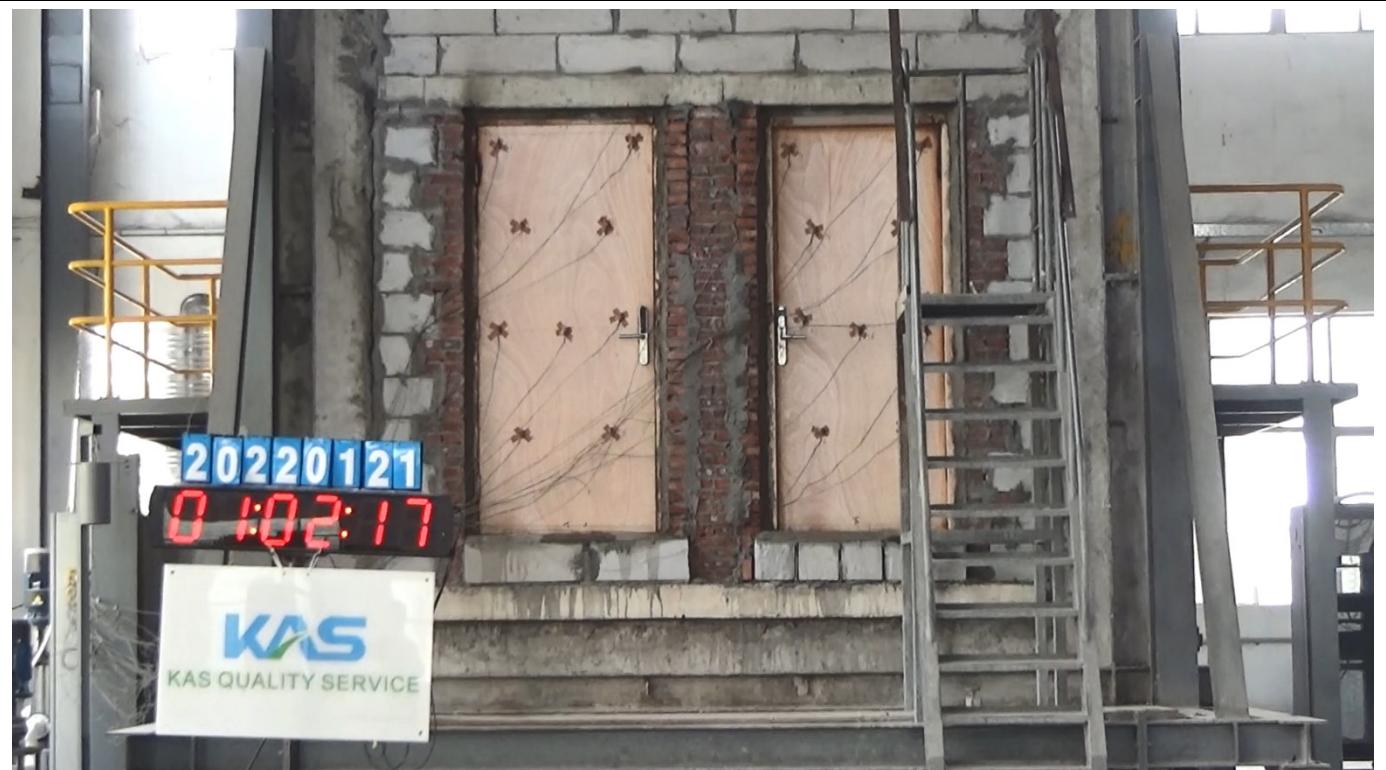
After 62 min (Unexposed Side)
